THREE RIVERS LOCAL PROTECTION PROJECT

*CHICOPEE, WARE and QUABOAG RIVERS
CONNECTICUT RIVER BASIN*

SITUATION REPORT

JULY 1976

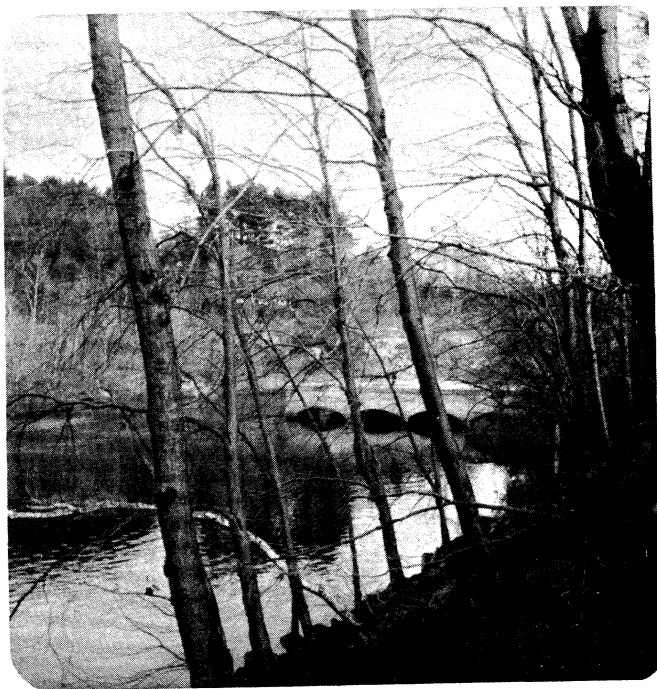
Site of Old New England Power
Company Dam on the Chicopee
River.

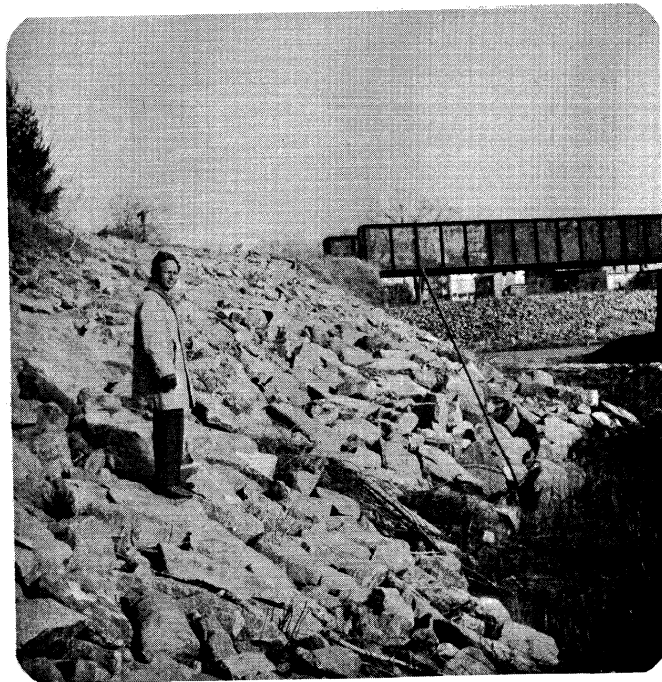
Stone Protection along Chicopee River just downstream of the confluence of the Ware and Quaboag Rivers.

2. Design criteria for stone revetments have changed significantly since this project was designed in 1963. The existing revetments were, therefore, evaluated in the light of current criteria. It was found that for the greater part of the project (upstream of the Bridge Street Bridge), the revetment satisfies current criteria. Downstream of the bridge the revetment is deficient in layer thicknesses according to current criteria. Modification of this portion of the revetment is not recommended; however, since its failure would not endanger life or cause extensive property damage.

3. The revetments are in good condition and show no sign of damage from erosion or weathering. They have been in place for twelve (12) years and exposed to flows of up to 7,000 cfs as compared to the design flood flow of 50,000 cfs.
